TECHNICAL SUPPORT BULLETIN

Models Affected: All FP-530 and FP-541 battery operated printers.

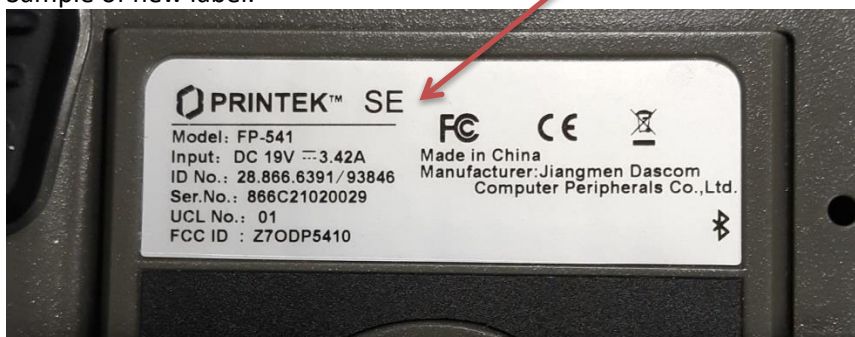
Sample of new label:

The new printer part numbers will be marked "SE" on the serial and shipping labels.

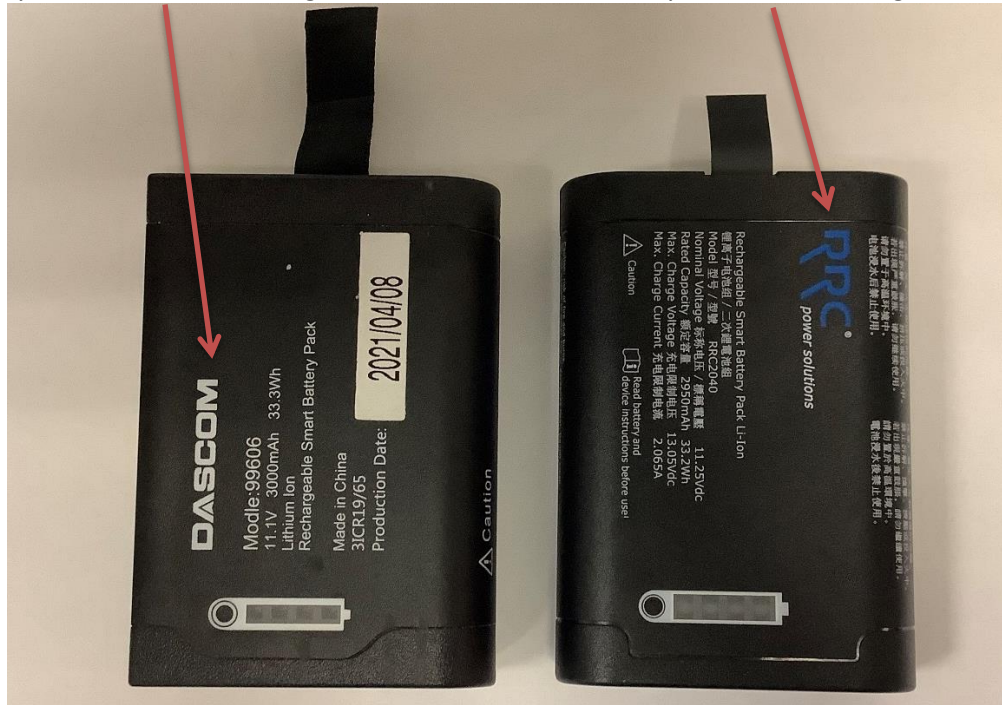
New SE battery with DASCOM branding

Older battery with RRC branding

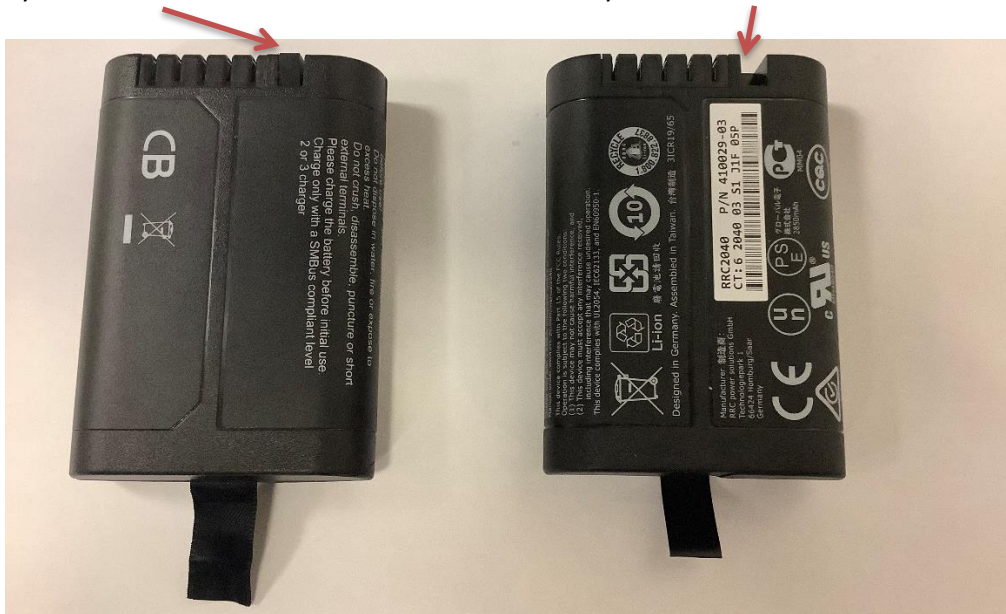
The new SE battery is modified with an insert to prevent the user from installing the new battery into an older printer.

New SE battery with insert

Old RRC battery without insert

DO NOT REMOVE THE INSERT AND USE THE DASCOM LABELED BATTERY IN A NON "SE" MODEL. THIS IS A POTENTIAL SAFETY/FIRE HAZARD.
